**Flood Control Project Maintenance
Levee Inspections
LMA District Cover Sheet
Spring 2010 Levee Inspection Results**

Reclamation District No. 0524 Middle Roberts Island

Levee Inspection Report By Mile - Spring 2010

Waterway						Bank	Unit Miles	Inspection Start/End	Inspector
Unit No. 01 San Joaquin River						Left	6.26	03/30/2010 04/05/2010	Richard Willoughby

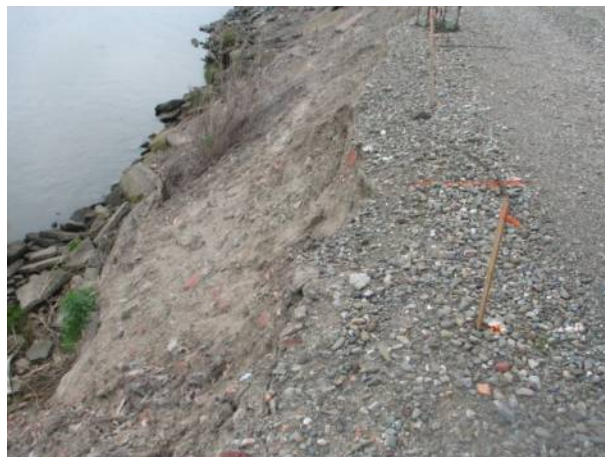
richard_s_20100316_039.jpg

Major erosion from LM 0.48 to 0.49

7	0.48	0.49	Earthen Levee	Erosion / Bank Caving	WS	U	Schedule repair of erosion site prior to the next inspection.	37.938693 ° -121.339063 °	37.938693 ° -121.338993 °	6 Y
8	0.51	0.52	Earthen Levee	Erosion / Bank Caving	WS	U	Schedule repair of erosion site prior to the next inspection.	37.938682 ° -121.338518 °	37.938657 ° -121.338425 °	7 Y
9	0.53	0.60	Supplemental	DWR Erosion Survey	WS	U	Inspector Comments: 2009: erosion site extends from RM 41.11 to 41.18; existing revetment is no longer adequately protecting the oversteepened slope [2009 SiteID:RD0524U1RM41.15]	37.938895 ° -121.337602 °	37.938895 ° -121.337602 °	1 Y
10	0.63	0.63	Earthen Levee	Slope Stability	WS	M	Repair the levee slope damaged by foot traffic and prevent access where possible.	37.938247 ° -121.336503 °	37.938247 ° -121.336503 °	10
11	0.63	0.64	Earthen Levee	Vegetation	WS	U	Remove the wild growth other than native grasses from the levee slopes.	37.938247 ° -121.336503 °	37.938197 ° -121.336405 °	11 Y

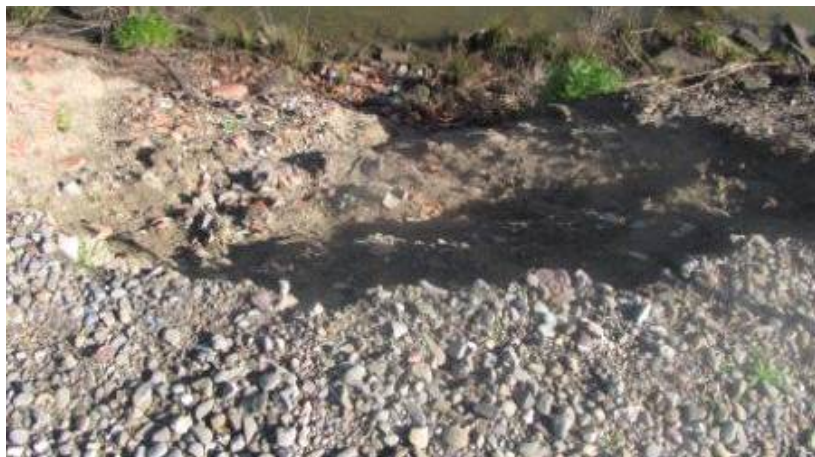
richard_s_20100408_206.jpg

Levee Mile Report Line	7
Start Levee Mile	0.48
End Levee Mile	0.49
Location	Water Side
Category	Earthen Levee
Item	Erosion / Bank Caving

Looking at erosion from the top of the levee (no change as of 4/2010)

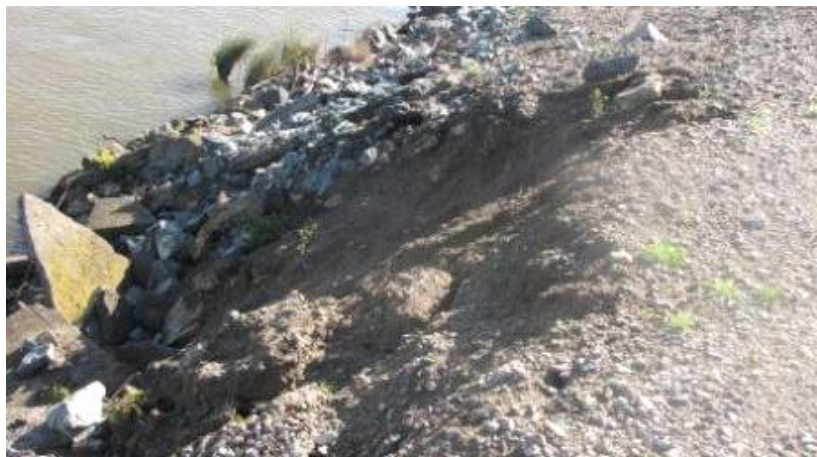
richard_s_20100408_207.jpg

Levee Mile Report Line	8
Start Levee Mile	0.51
End Levee Mile	0.52
Location	Water Side
Category	Earthen Levee
Item	Erosion / Bank Caving

Looking southeast at erosion on waterside slope ,
no change as of 4/2010)

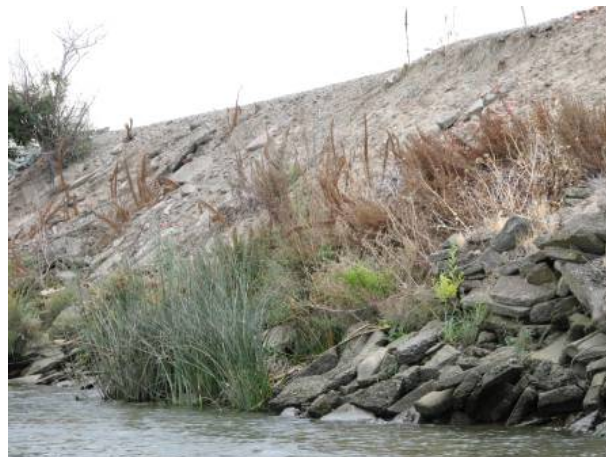
SJR2009_RM41.11 092909F.JPG

Levee Mile Report Line	9
Start Levee Mile	0.53
End Levee Mile	0.60
Location	Water Side
Category	Supplemental
Item	DWR Erosion Survey

2009: erosion site extends from RM 41.11 to 41.18; existing revetment is no longer adequately protecting the oversteepened slope [2009 SiteID:RD0524U1RM41.15]

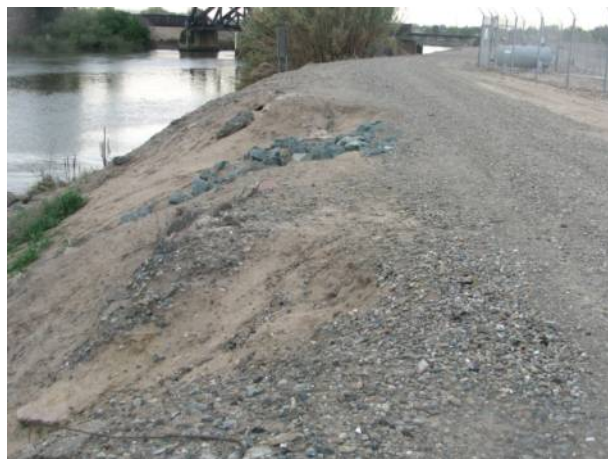
richard_s_20100316_045.jpg

Erosion from LM 0.65 to 0.66

12	0.64	0.64	Earthen Levee	Crown Surface / Depressions / Rutting	CR	M	Regrade the crown roadway for proper drainage.	37.938198 ° -121.336407 °	37.938198 ° -121.336407 °	12 Y
13	0.65	0.66	Earthen Levee	Slope Stability	WS	M	Repair slope instability.	37.938105 ° -121.336288 °	37.938023 ° -121.336173 °	13 Y
14	0.68	0.68	Earthen Levee	Vegetation	WS	U	Remove the wild growth other than native grasses from the levee slopes.	37.937808 ° -121.335913 °	37.937808 ° -121.335913 °	14 Y
15	0.79	0.79	Earthen Levee	Trim / Thin Trees	LS	M	Trim trees to at least five feet above ground level.	37.936444 ° -121.334797 °	37.936444 ° -121.334797 °	76
16	0.81	0.81	Earthen Levee	Erosion / Bank Caving	WS	M	Note and monitor erosion site.	37.936217 ° -121.334698 °	37.936217 ° -121.334698 °	16

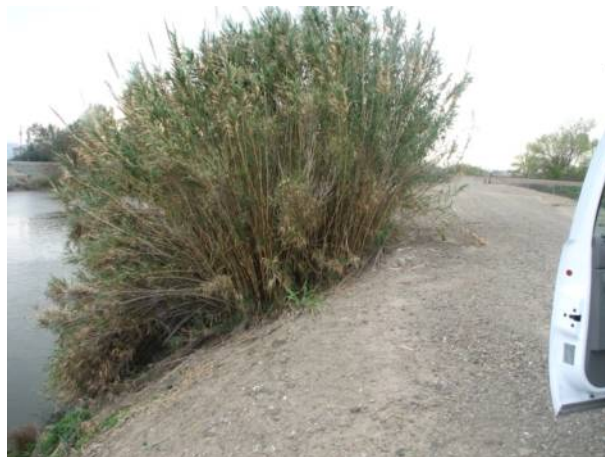
richard_s_20100316_047.jpg

Bamboo on waterward slope at LM 0.68

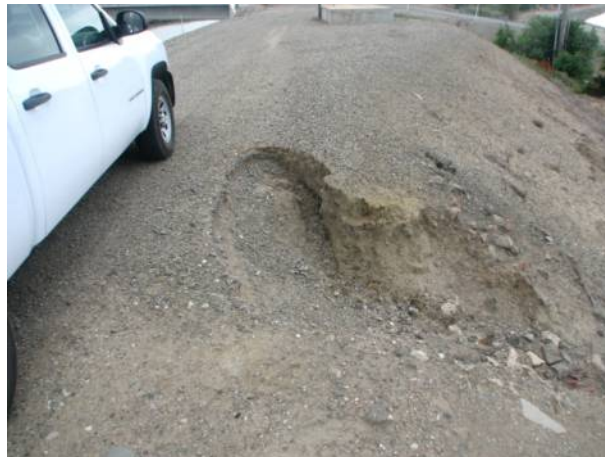
richard_s_20100316_050.jpg

Landward slope damage at LM 1.09

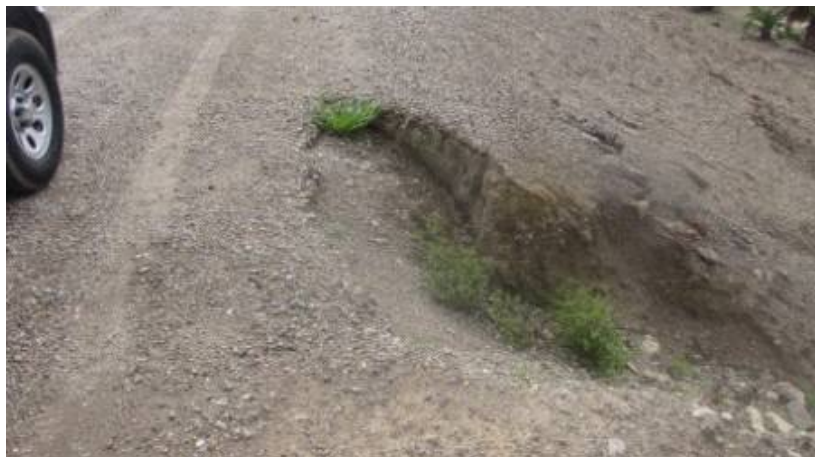
richard_s_20100408_213.jpg

Looking at updated slope stability as 4/2010

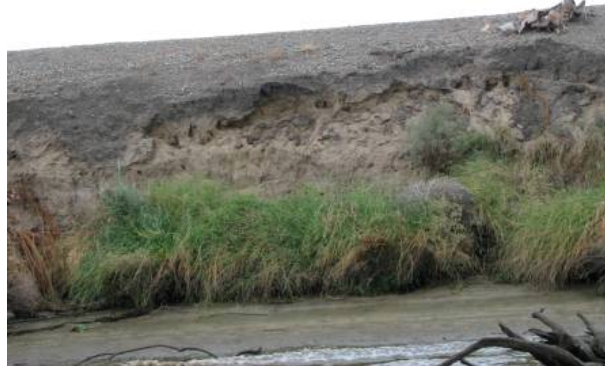
Levee Mile Report Line	21
Start Levee Mile	1.16
End Levee Mile	1.24
Location	Water Side
Category	Supplemental
Item	DWR Erosion Survey
<p>2009: Site consists of an approximately 400 ft. eroding bank with minimal protection; the existing rip rap is sloughing; note there is an exposed section of a pipe [2009 SiteID:RD0524U1RM41.79]</p> <p>SJR2009_RM41.79 092909A.JPG</p>

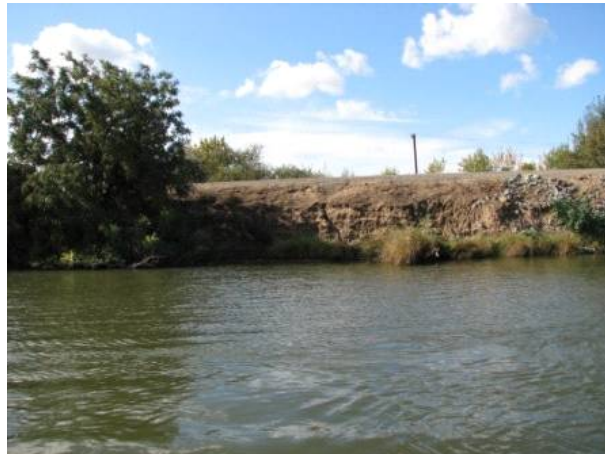
Levee Mile Report Line	21
Start Levee Mile	1.16
End Levee Mile	1.24
Location	Water Side
Category	Supplemental
Item	DWR Erosion Survey
<p>2009: Site consists of an approximately 400 ft. eroding bank with minimal protection; the existing rip rap is sloughing; note there is an exposed section of a pipe [2009 SiteID:RD0524U1RM41.79]</p> <p>SJR2009_S18 LM1.20 110408a.jpg</p>

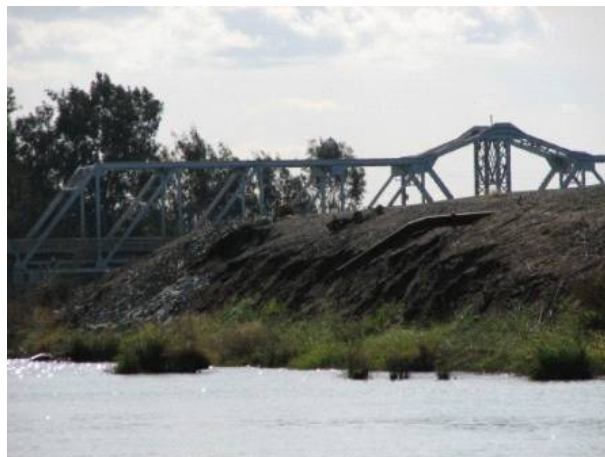
Levee Mile Report Line	21
Start Levee Mile	1.16
End Levee Mile	1.24
Location	Water Side
Category	Supplemental
Item	DWR Erosion Survey
<p>2009: Site consists of an approximately 400 ft. eroding bank with minimal protection; the existing rip rap is sloughing; note there is an exposed section of a pipe [2009 SiteID:RD0524U1RM41.79]</p> <p>SJR2009_S18 LM1.20 110408b.jpg</p>

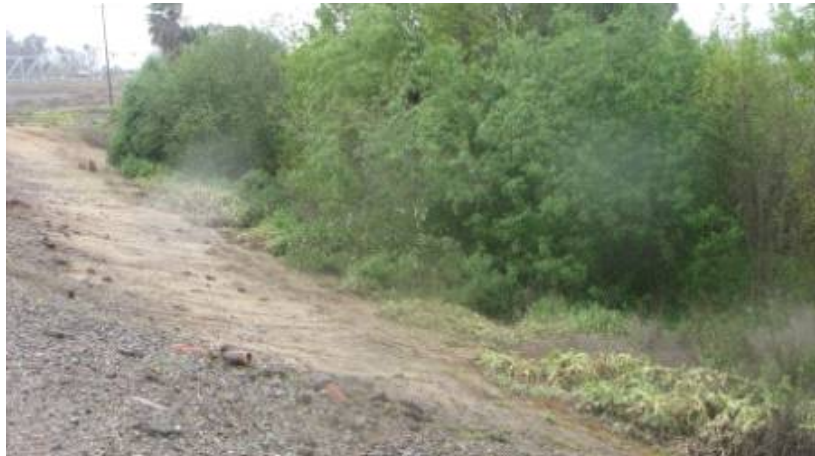
richard_s_20100408_214.jpg

Looking southwest at dense veg. on landside toe.

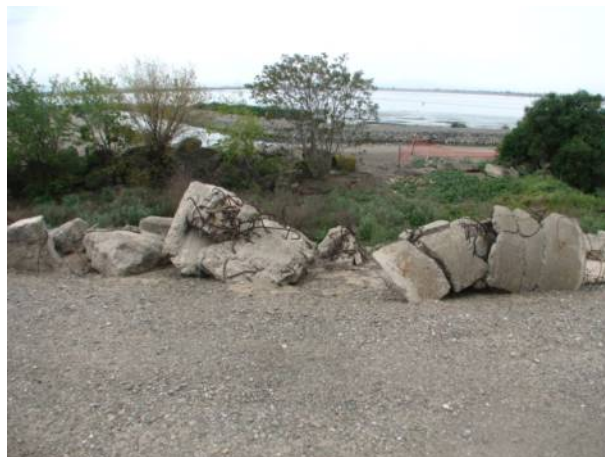
richard_s_20100316_052.jpg

Levee Mile Report Line	23
Start Levee Mile	1.25
End Levee Mile	1.25
Location	Land Side
Category	Earthen Levee
Item	Encroachments

Concrete rubble with rebar on landward shoulder at LM 1.25

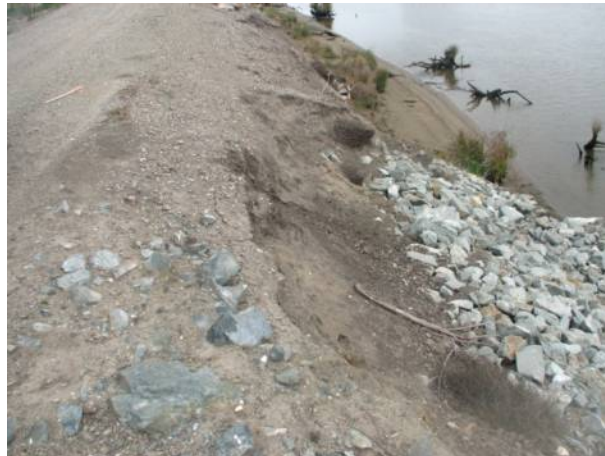
richard_s_20100316_053.jpg

Erosion from LM 1.32 to 1.33

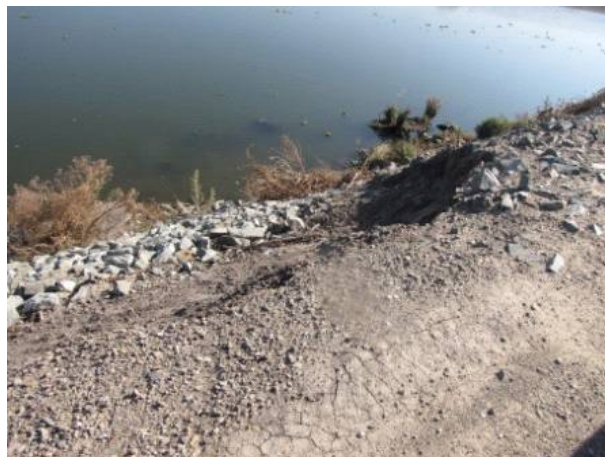
richard_s_20100316_054.jpg

Levee Mile Report Line	24
Start Levee Mile	1.32
End Levee Mile	1.33
Location	Water Side
Category	Earthen Levee
Item	Erosion / Bank Caving

Looking at erosion from top of levee

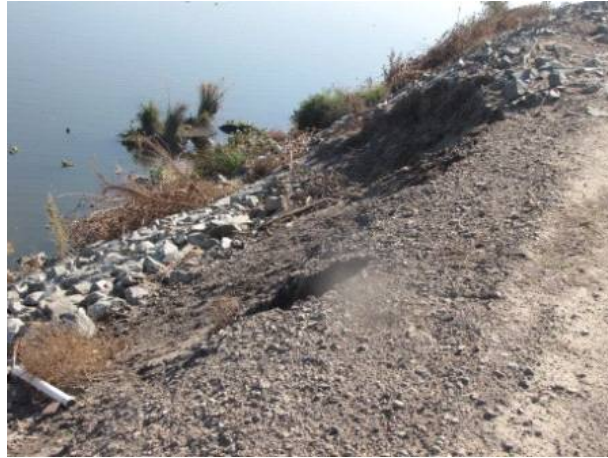
richard_s_20100316_055.jpg

Looking at update of erosion site at LM 1.32 to 1.33

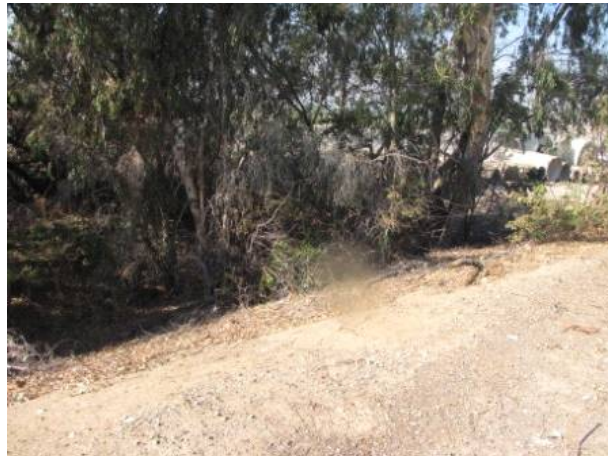
richard_s_20100316_069.jpg

Levee Mile Report Line	26
Start Levee Mile	1.51
End Levee Mile	1.51
Location	Land Side
Category	Earthen Levee
Item	Trim / Thin Trees

Dense vegetation on landside toe.

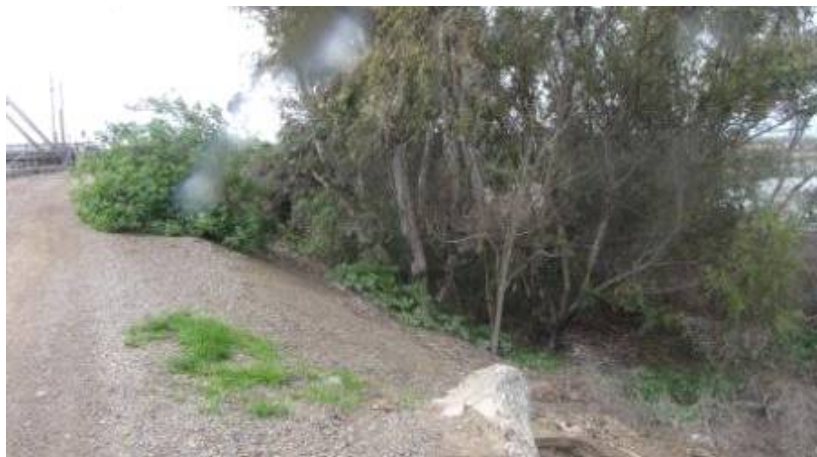
richard_s_20100408_216.jpg

Levee Mile Report Line	26
Start Levee Mile	1.51
End Levee Mile	1.51
Location	Land Side
Category	Earthen Levee
Item	Trim / Thin Trees

Looking south at dense veg. on landside slope and toe.

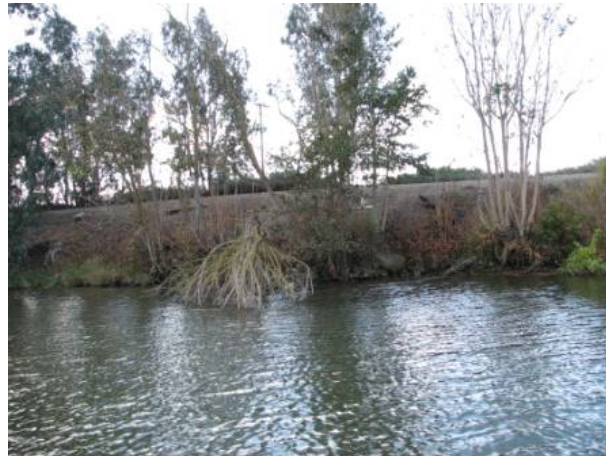
Levee Mile Report Line	28
Start Levee Mile	1.58
End Levee Mile	1.64
Location	Water Side
Category	Supplemental
Item	DWR Erosion Survey
2009: The lower slope is lined with some erosion pockets; some tree roots are exposed; there is visible undermining of the levee toe; site is immediately upstream of the Highway 4 Bridge; the bridge is possibly causing a scour to occur, eroding the bank [2009 SiteID:RD0524U1RM42.2]	
SJR2009_S21 LM1.61 110408a.jpg

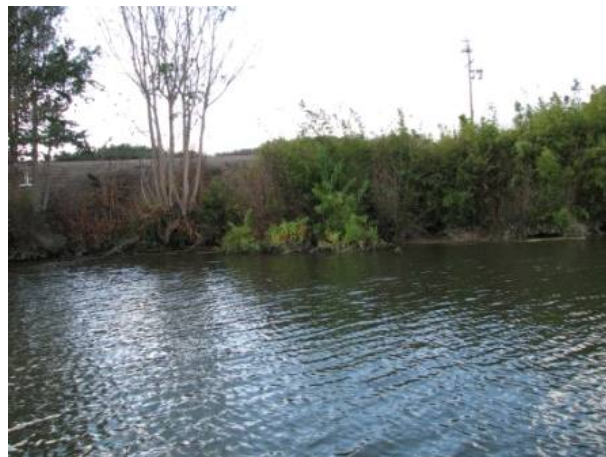
Levee Mile Report Line	28
Start Levee Mile	1.58
End Levee Mile	1.64
Location	Water Side
Category	Supplemental
Item	DWR Erosion Survey
2009: The lower slope is lined with some erosion pockets; some tree roots are exposed; there is visible undermining of the levee toe; site is immediately upstream of the Highway 4 Bridge; the bridge is possibly causing a scour to occur, eroding the bank [2009 SiteID:RD0524U1RM42.2]	
SJR2009_S21 LM1.61 110408b.jpg

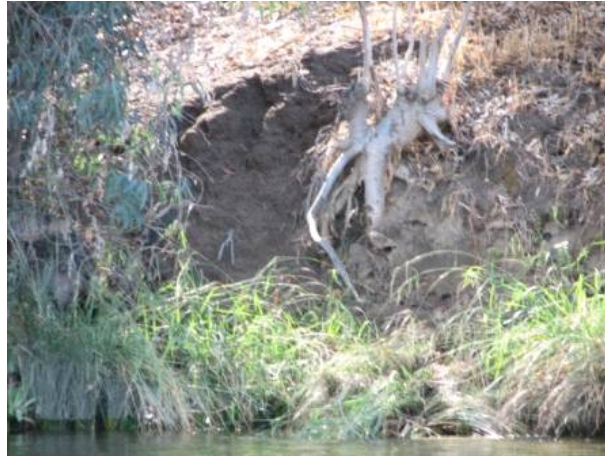
SJR2009_S21 LM1.61 110408c.jpg

2009: The lower slope is lined with some erosion pockets; some tree roots are exposed; there is visible undermining of the levee toe; site is immediately upstream of the Highway 4 Bridge; the bridge is possibly causing a scour to occur, eroding the bank [2009 SiteID:RD0524U1RM42.2]

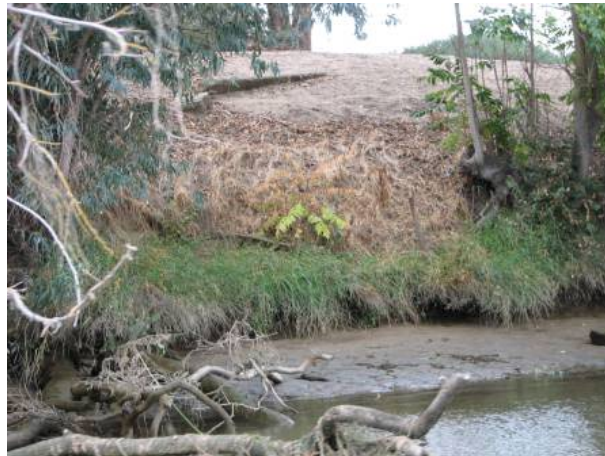
SJR2009_RM42.20U1 092909K.JPG

Levee Mile Report Line	28
Start Levee Mile	1.58
End Levee Mile	1.64
Location	Water Side
Category	Supplemental
Item	DWR Erosion Survey

2009: The lower slope is lined with some erosion pockets; some tree roots are exposed; there is visible undermining of the levee toe; site is immediately upstream of the Highway 4 Bridge; the bridge is possibly causing a scour to occur, eroding the bank [2009 SiteID:RD0524U1RM42.2]

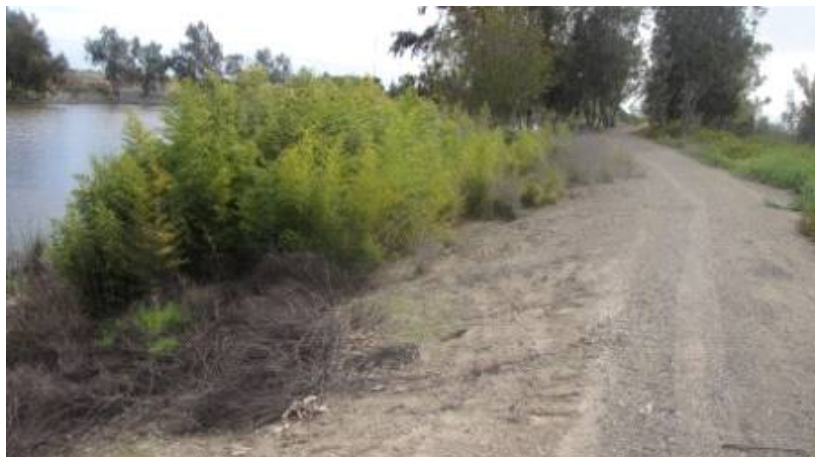
richard_s_20100408_217.jpg

Levee Mile Report Line	30
Start Levee Mile	1.62
End Levee Mile	1.63
Location	Water Side
Category	Earthen Levee
Item	Vegetation

Looking southeast at dense veg. on waterside slope.

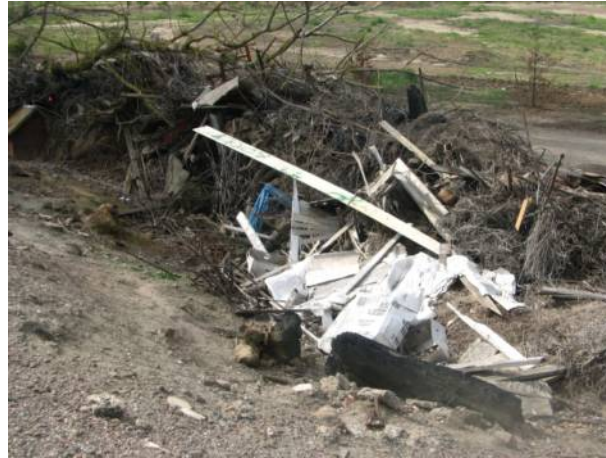
richard_s_20100316_057.jpg

Garbage on landward toe from LM 1.75 to 1.76

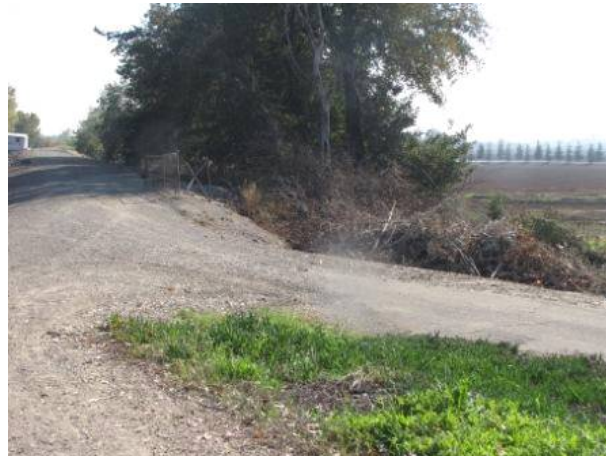
richard_s_20100316_058.jpg

Levee Mile Report Line	34
Start Levee Mile	1.75
End Levee Mile	1.75
Location	Land Side
Category	Earthen Levee
Item	Encroachments

Looking at updated trash pile on landside slope and toe.

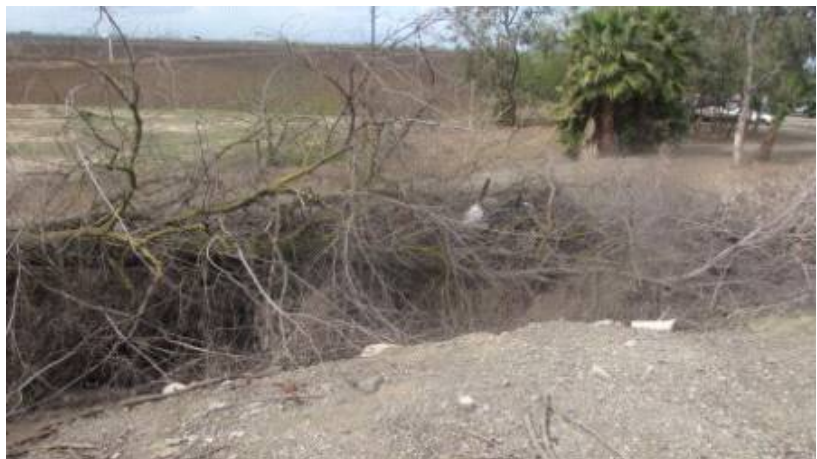
richard_s_20100408_218.jpg

Levee Mile Report Line	34
Start Levee Mile	1.75
End Levee Mile	1.75
Location	Land Side
Category	Earthen Levee
Item	Encroachments

Looking west at prunings on landside toe.

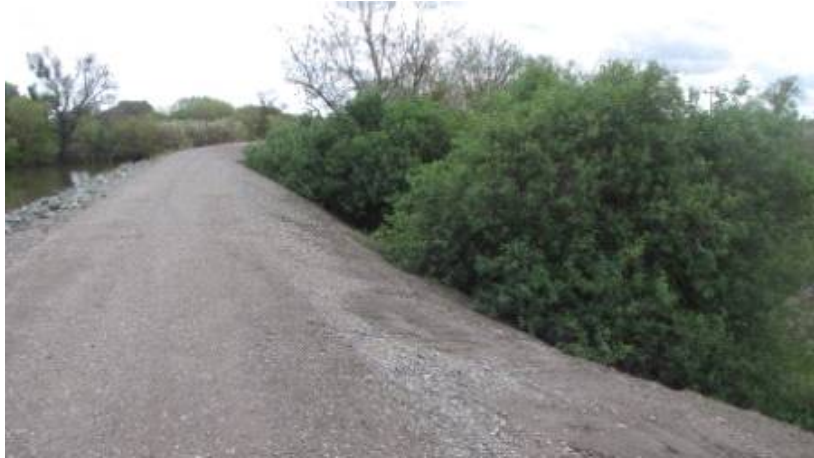
richard_s_20100408_219.jpg

Looking south at dense veg on landside slope and toe.

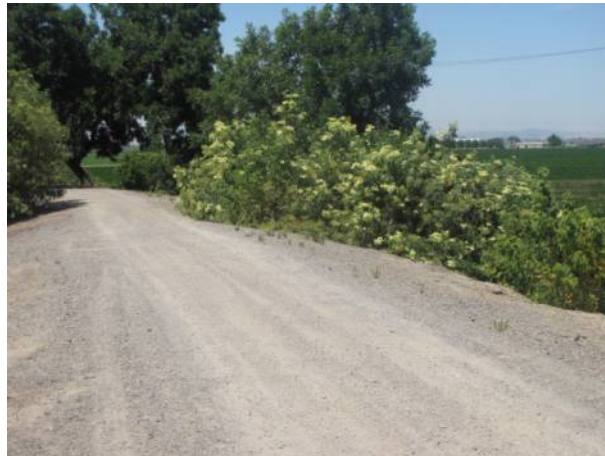
jhirabay_s_20100625_225.jpg

Levee Mile Report Line	46
Start Levee Mile	2.52
End Levee Mile	2.52
Location	Land Side
Category	Earthen Levee
Item	Vegetation

Looking south at elderberry on landside slope.

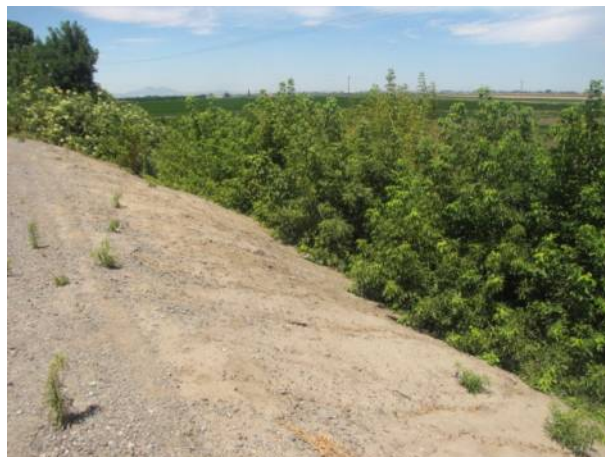
jhirabay_s_20100625_226.jpg

Levee Mile Report Line	46
Start Levee Mile	2.52
End Levee Mile	2.52
Location	Land Side
Category	Earthen Levee
Item	Vegetation

Looking southwest at trees along levee landside toe.

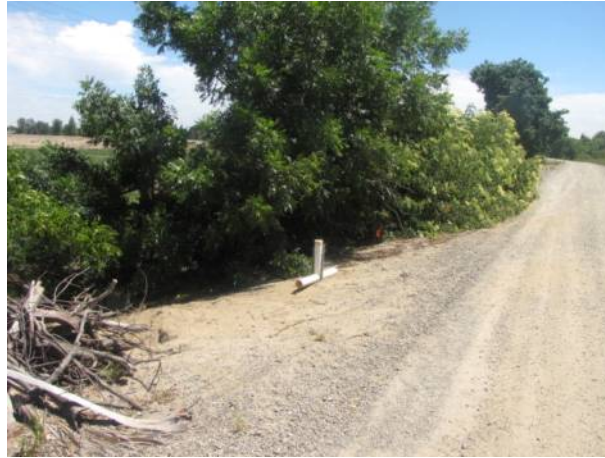
jhirabay_s_20100625_229.jpg

Looking north at elderberry and trees on landside slope.

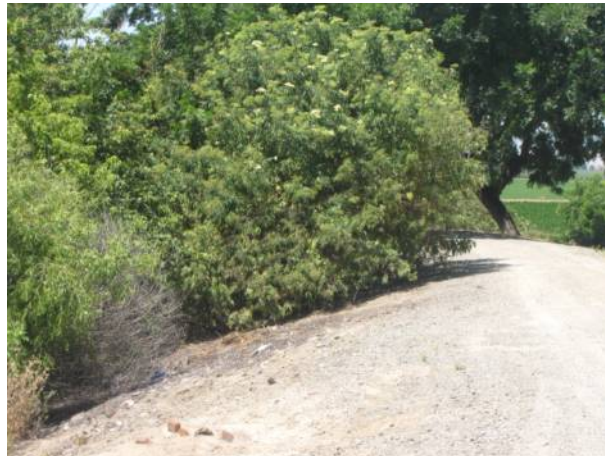
jhirabay_s_20100625_227.jpg

Levee Mile Report Line	47
Start Levee Mile	2.53
End Levee Mile	2.53
Location	Water Side
Category	Earthen Levee
Item	Vegetation

Looking south at elderberry on waterside slope.

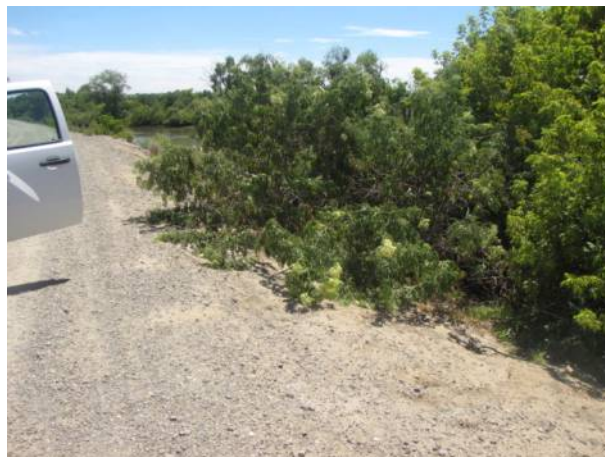
jhirabay_s_20100625_228.jpg

Levee Mile Report Line	47
Start Levee Mile	2.53
End Levee Mile	2.53
Location	Water Side
Category	Earthen Levee
Item	Vegetation

Looking north at elderberry on waterside slope.

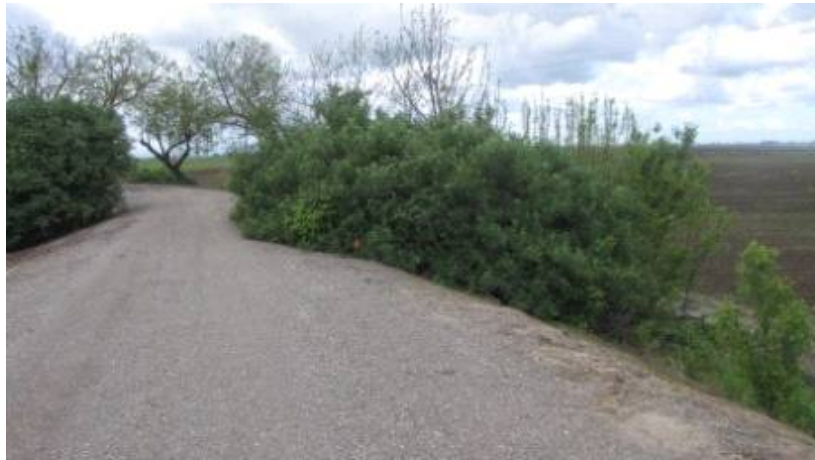
richard_s_20100408_220.jpg

Looking southwest at elderberrys on landside slope.

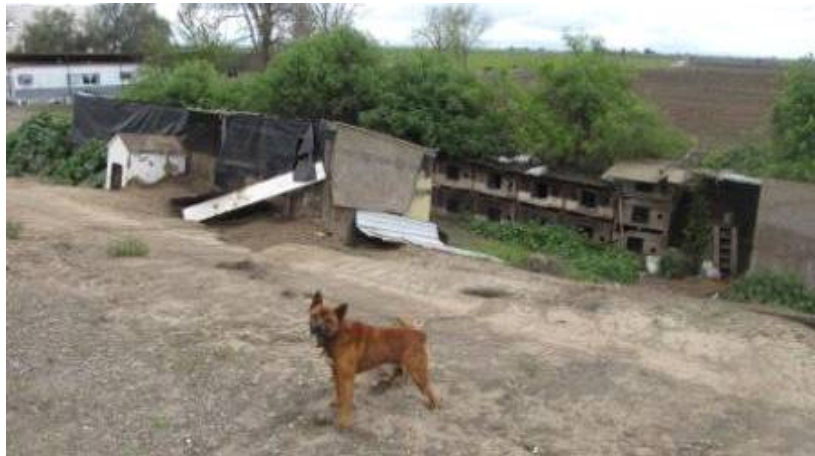
richard_s_20100408_221.jpg

Levee Mile Report Line	55
Start Levee Mile	2.66
End Levee Mile	2.66
Location	Land Side
Category	Earthen Levee
Item	Vegetation

Looking southwest at structures on landside.

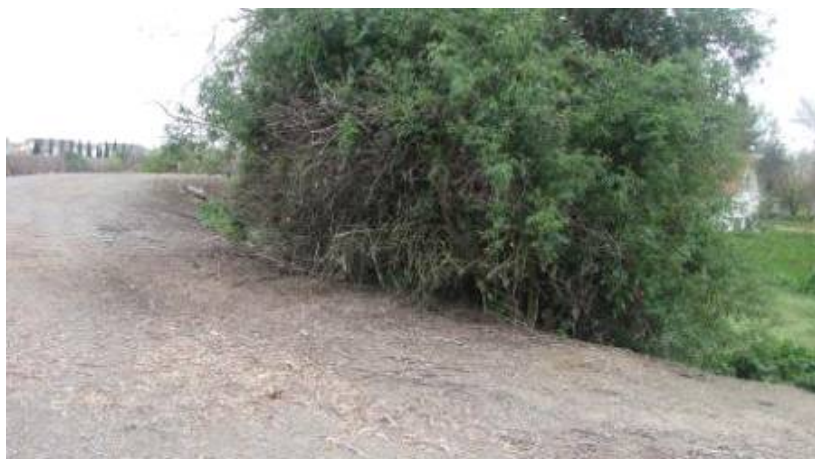
richard_s_20100408_222.jpg

Levee Mile Report Line	63
Start Levee Mile	2.79
End Levee Mile	2.81
Location	Land Side
Category	Earthen Levee
Item	Slope Stability

Looking southwest at elderberry on landside slope.

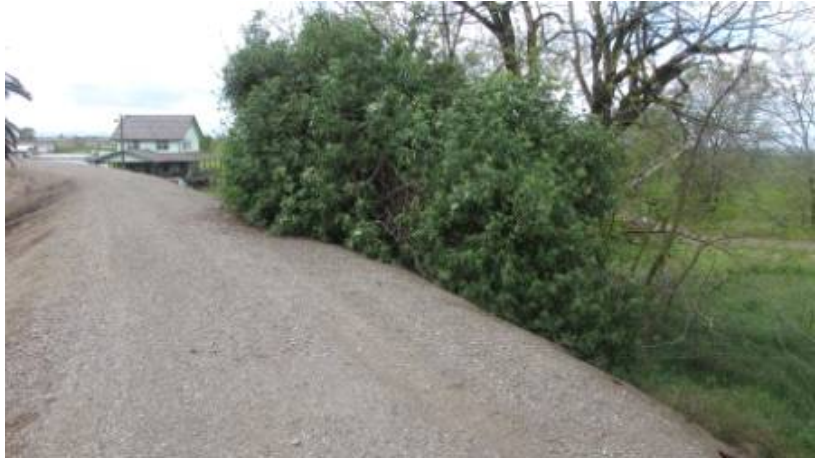
richard_s_20100408_224.jpg

Looking south at elderberry on landside slope.

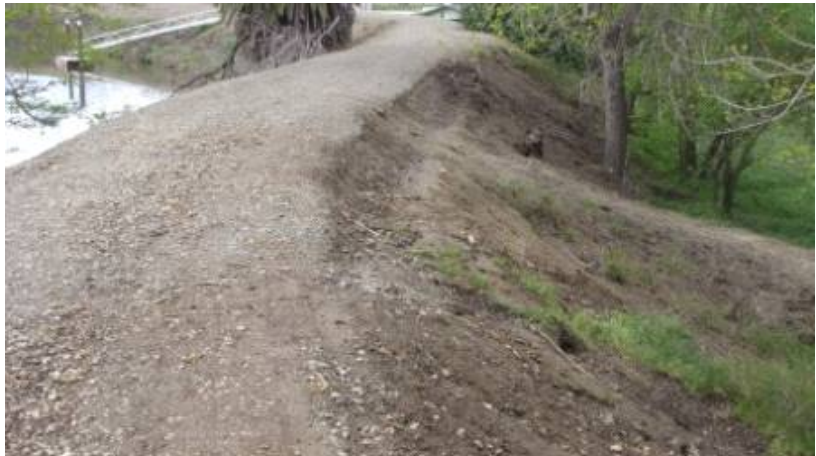
richard_s_20100408_223.jpg

Levee Mile Report Line	82
Start Levee Mile	3.68
End Levee Mile	3.68
Location	Water Side
Category	Earthen Levee
Item	Slope Stability

Looking south at slope stability on landside shoulder.

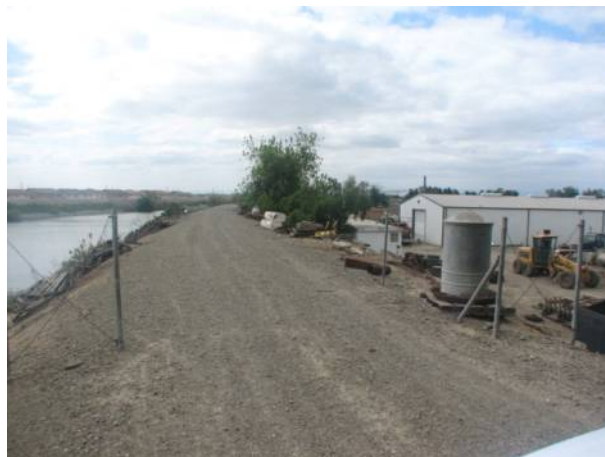
richard_s_20100316_061.jpg

Levee Mile Report Line	87
Start Levee Mile	3.89
End Levee Mile	4.01
Location	Land Side
Category	Earthen Levee
Item	Encroachments

Looking upstream at equipment on landside shoulder

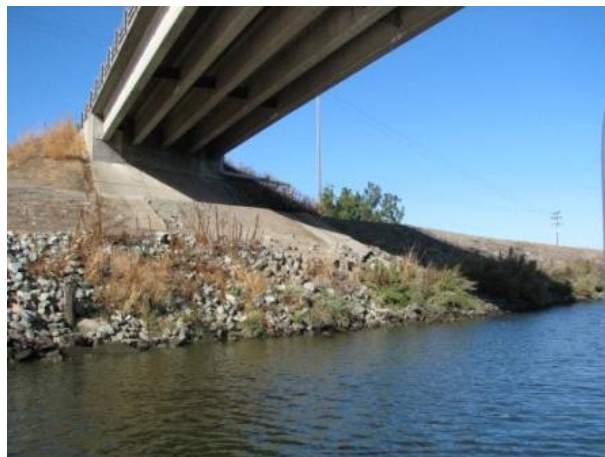
SJR2009_S48.5 LM5.65 110408b.jpg

2009: no major change observed; upper portion of the existing revetment has slipped, exposing the degraded bank; note the site # is same as RM 46.3, LM5.69 found in the CLRO CES Evaluation 2008 Report; ste was previously rated "M" [2009 SiteID:RD0524U1RM46.12]

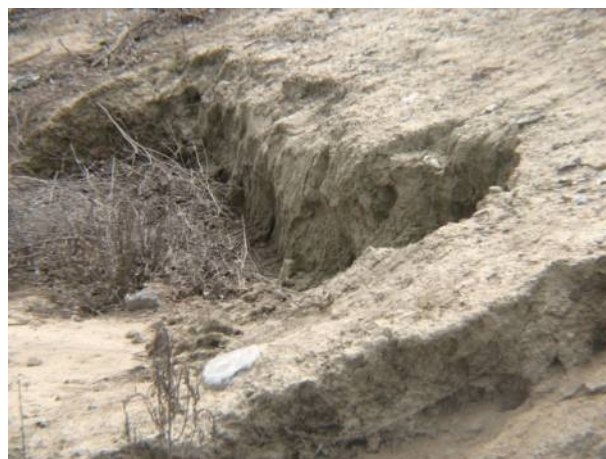
richard_s_20100316_067.jpg

Erosion at waterward toe at LM 5.92

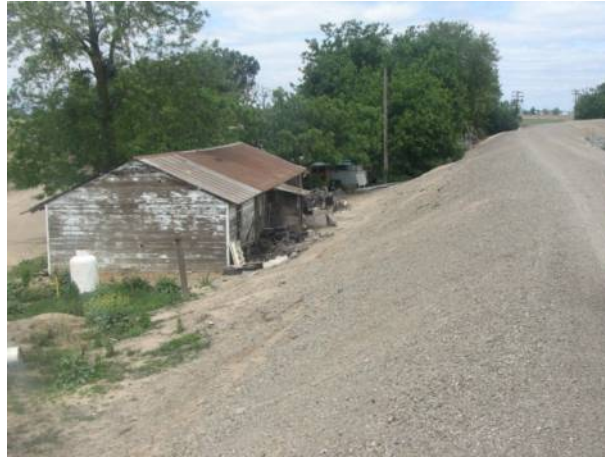
richard_s_20100316_068.jpg

Looking downstream at building on landside toe.
